CAFO FACILITY INSPECTION REPORT

<u>8365940001</u> WDID NUMBER	<u>Rodger Camping</u> OWNER NAME	<u>Eagle Livestock</u> FACILITY NAME
<u>CAG018001</u> NPDES NUMBER	<u>Ex. 6 Personal Privacy (PP)</u> OWNER ADDRESS	<u>Ex. 6 Personal Privacy (PP)</u> FACILITY ADDRESS
<u>R8-2007-0001</u> RWQCB ORDER NO.	<u>Chino, CA 91710</u> OWNER CITY AND STATE	<u>Ontario, CA 91762</u> FACILITY CITY AND STATE
<u>03/05/2013</u> SCHEDULED INSPECTION DATE	<u>Rodger Camping</u> OWNER CONTACT	<u>Kyle Fulmer</u> FACILITY CONTACT
<u>03/05/2013</u> ACTUAL INSPECTION DATE	<u>Ex. 6 Personal Privacy (PP)</u> OWNER PHONE NO.	<u>Ex. 6 Personal Privacy (PP)</u> FACILITY PHONE NO.
<u>Unknown</u> RECEIVING WATER	<u>Ex. 6 Personal Privacy (PP)</u>

On March 5, 2013, a Concentrated Animal Feeding Operation (CAFO) inspection was conducted for Santa Ana Water Board Order No. R8-2007-0001 - 'General Waste Discharge Requirements for Concentrated Animal Feeding Operations (Dairies and Related Facilities) within the Santa Ana Region', NPDES General Permit No. (CAG018001) at Eagle Livestock in Ontario, California (refer to Photo 1). The inspectors provided a phone call and left a voicemail for Mr. Rodger Camping (Owner, Eagle

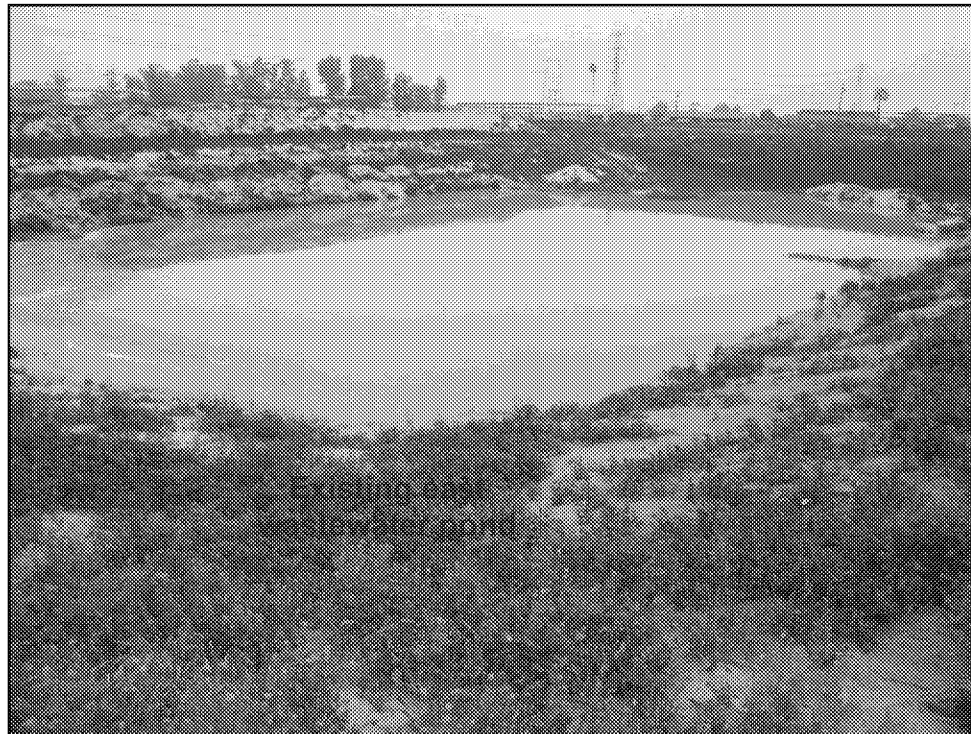
1. Depth markers were not installed in the existing east process wastewater pond, or in the other six (6) catch basins identified onsite during the inspection, as required by Permit Attachment B - Monitoring and Reporting Program, Section I.B.1 (refer to Photos 2, 3, and 4). This is a recurring issue identified in a previous inspection conducted on December 22, 2010.

1. The inspectors observed, during the inspection, that depth markers were not installed in the existing east process wastewater pond, or in the other six (6) catch basins identified onsite during the inspection as required by Permit Attachment B - Monitoring and Reporting Program, Section I.B.1 (refer to Photos 2, 3, and 4). A depth marker was present in the existing west process wastewater pond located in the southwest corner of the Facility (refer to Photos 16, 17, and 18). Process wastewater was present in the existing east wastewater pond, as well as in five (5) of the six (6) catch basins identified onsite during the inspection; however, the inspectors could not verify the depth of the process wastewater in each containment structure due to the lack of depth markers. This is a recurring issue identified in a previous inspection conducted on December 22, 2010.

Photograph 2. View facing northeast of the existing east process wastewater pond located in the southeast corner of the Facility. Note process wastewater was observed actively flowing into the northwest corner of the pond. Also note the pond did not contain a depth marker.

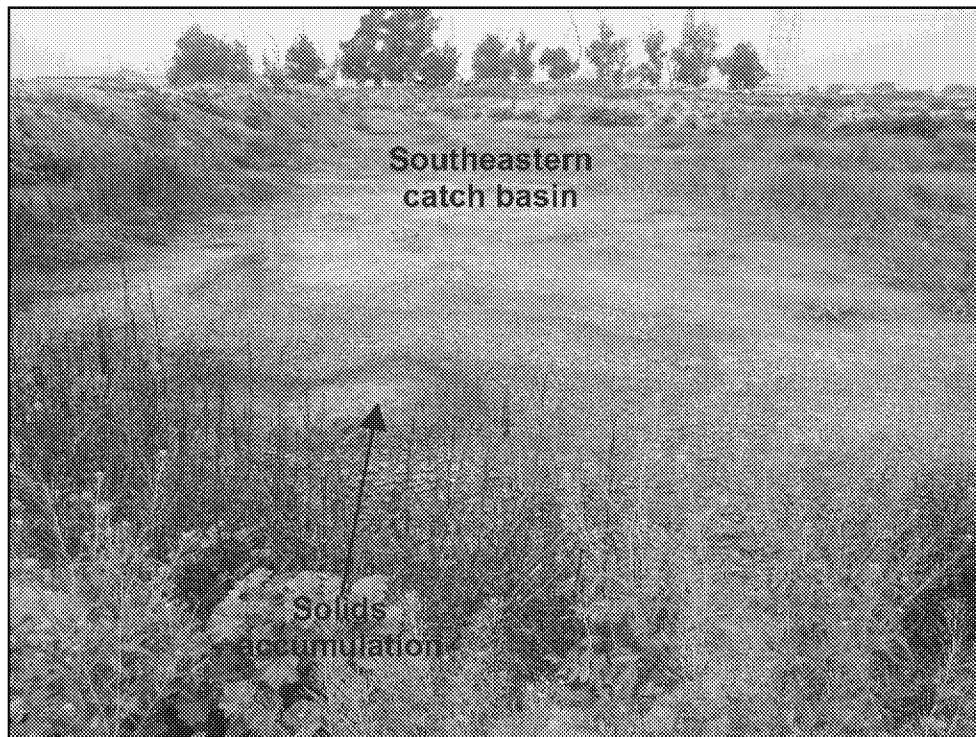
- Solids accumulation was observed in the southeastern catch basin (refer to Photo 3)
- Unconsolidated soil stockpiles were observed along the southern embankment slope of the existing west process wastewater pond (refer to Photos 16 and 18). The overflow spillway in the existing west process wastewater pond was observed to be obstructed by multiple unconsolidated soil stockpiles (refer to Photo 18)

4. The inspectors observed, during the inspection, solids accumulation in the southeastern catch basin in the southeast corner of the Facility (refer to Photo 3). The catch basin did not contain a depth marker; therefore, the inspectors were unable to determine the depth of accumulated solids in the basin. Mr. Fulmer stated that he was unaware of a cleaning frequency for the containment structures onsite, or if they had ever been cleaned. The 'Operation and Maintenance' section of the EWMP states that "the pond[s] will be drained each year and if manure covers the bottom, it will be removed." Provision VII.C.3.a of the Permit states that "the discharger shall design, construct, and maintain containment structures to retain all wastewater within the facility, including all process wastewater and all precipitation on, and drainage through, manured areas resulting from rainfall up to and including a 25-year, 24-hour rainfall event." The Discharger must design and maintain all containment structures per the EWMP as required by Provision VII.C.3.a of the Permit.

Photograph 3. View facing west of the dry southeastern catch basin, located immediately north of the existing east process wastewater pond. Note the basin did not contain a depth marker. Also note the solids accumulation within the basin.

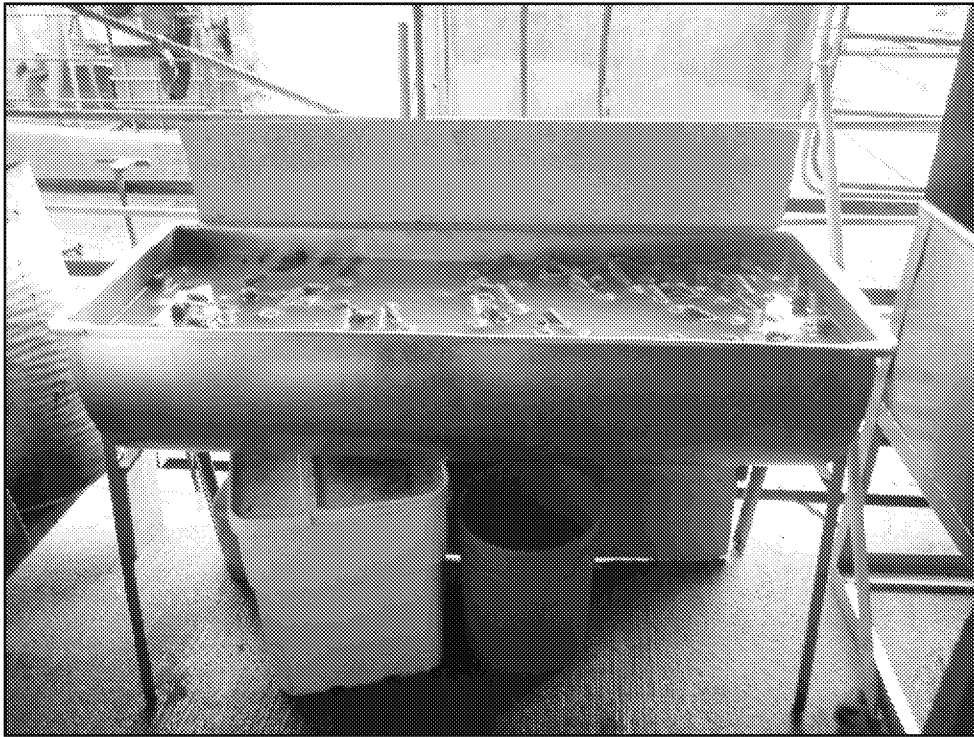
3. The EWMP was not reflective of current Facility conditions at the time of the inspection as required by the Permit. The 'Existing Waste Management System' section of the EWMP states "there is no wash water generated at this site." The inspectors observed bottle washing activities occurring at the calf milk production area in the central-east portion of the Facility (refer to Photos 5 and 6). Wash water (i.e., process wastewater) was observed actively flowing out of a valve head in the central portion of the site, and flowing via a surface conveyance ditch to the existing east process wastewater pond (refer to Photos 7 through 12). The EWMP does not identify bottle rinsing activities as a source of process wastewater for the Facility. As a result, the EWMP was not representative of current Facility conditions at the time of the inspection. Provision VII.C.3.b of the Permit states that "the discharger shall develop and fully implement an Engineered Waste Management Plan (EWMP) acceptable to the Executive Officer." The Discharger shall fully implement the EWMP as required by Provision VII.C.3.b of the Permit.

Photograph 5. Close-up view of bottle washing activities at the calf milk production area in the central-east portion of the Facility. Note the approved EWMP states that no wash water (i.e., process wastewater) is produced at the Facility.

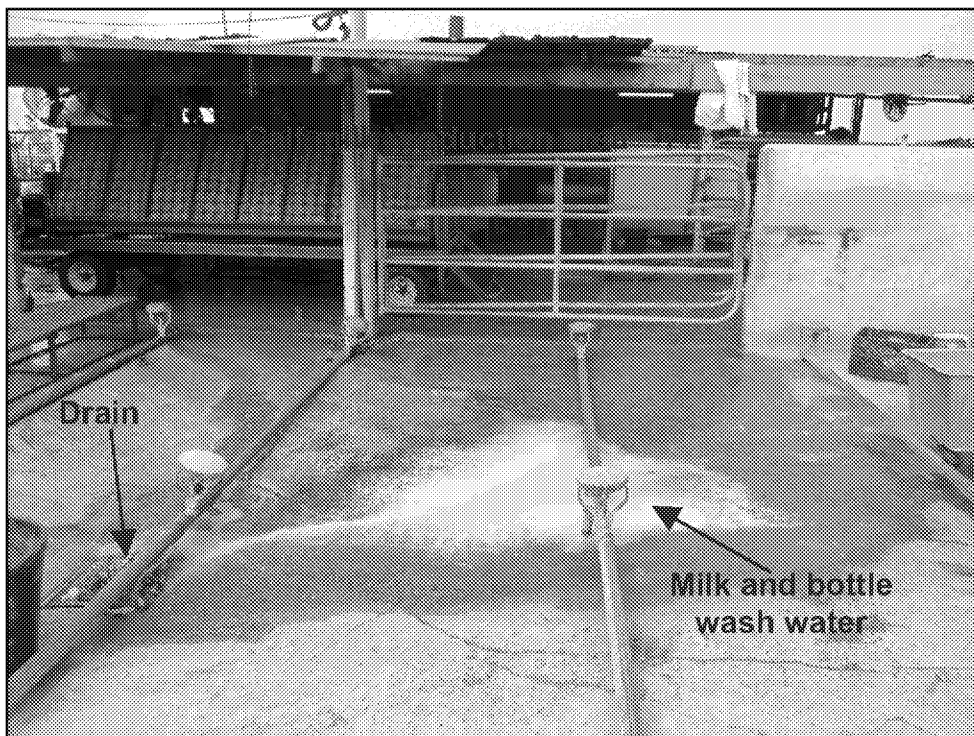
Photograph 6. View facing west of wash water entering an existing drain located in the inactive wash pen. This wash water (i.e., process wastewater) is piped south to the basins and ponds.

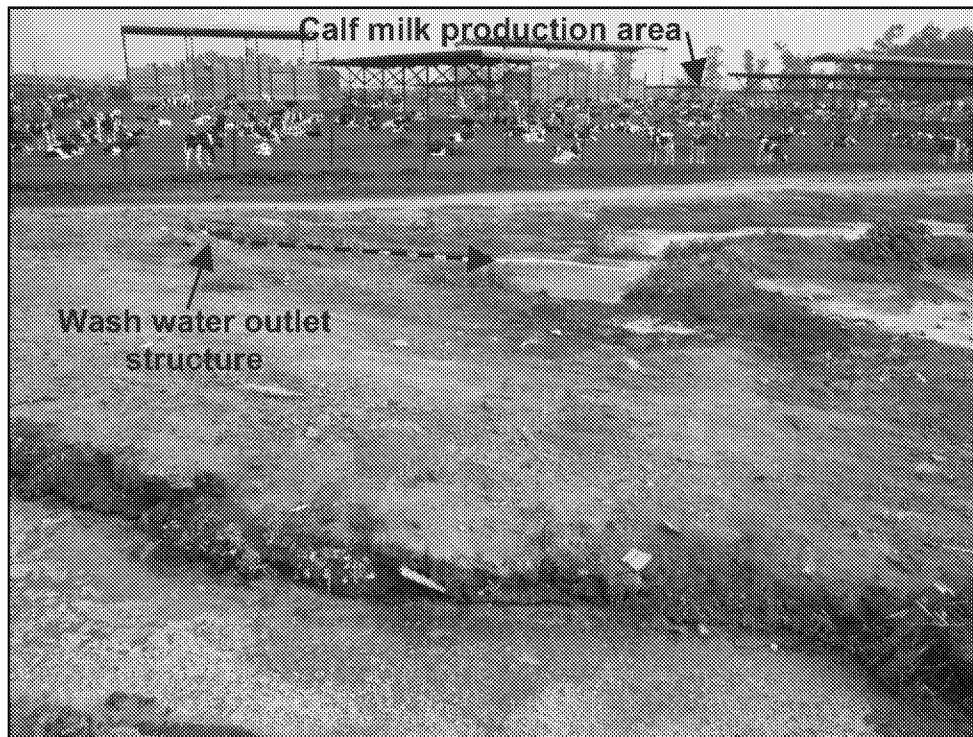
Photograph 7. View facing north of the wash water (shown in Photograph 6) outlet structure located in the central portion of the Facility, downgradient of the southern corrals.

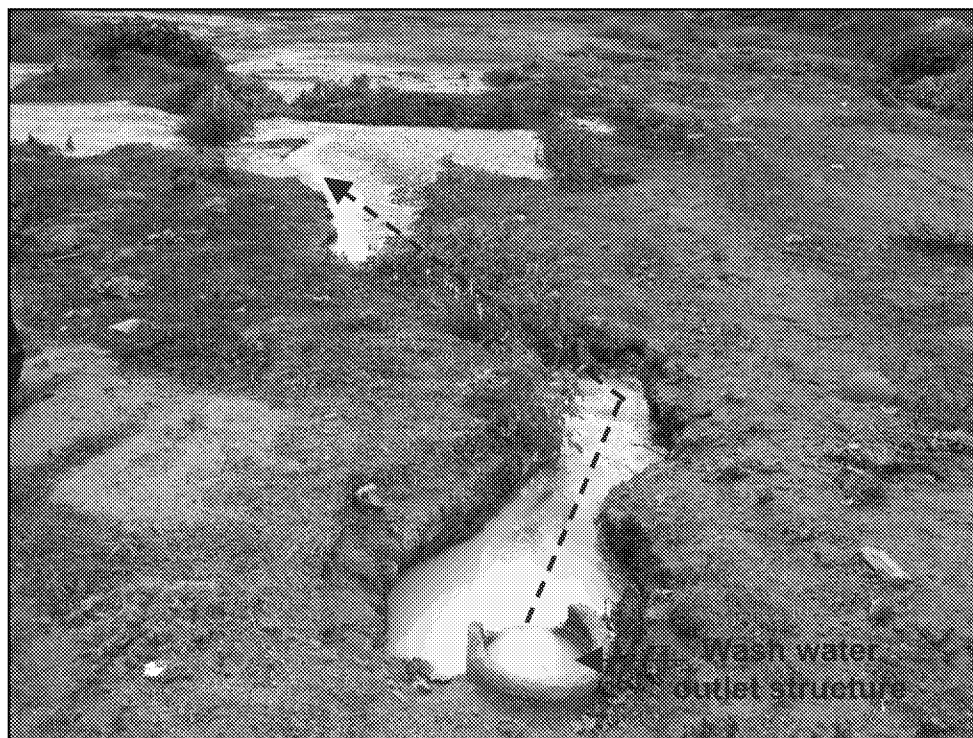
Photograph 8. View facing south of the wash water outlet structure and flow pathway. Wash water flows through a dirt area and into a surface conveyance ditch that runs north/south between the catch basins. Wash water was actively flowing into the basins at the time of the inspection.

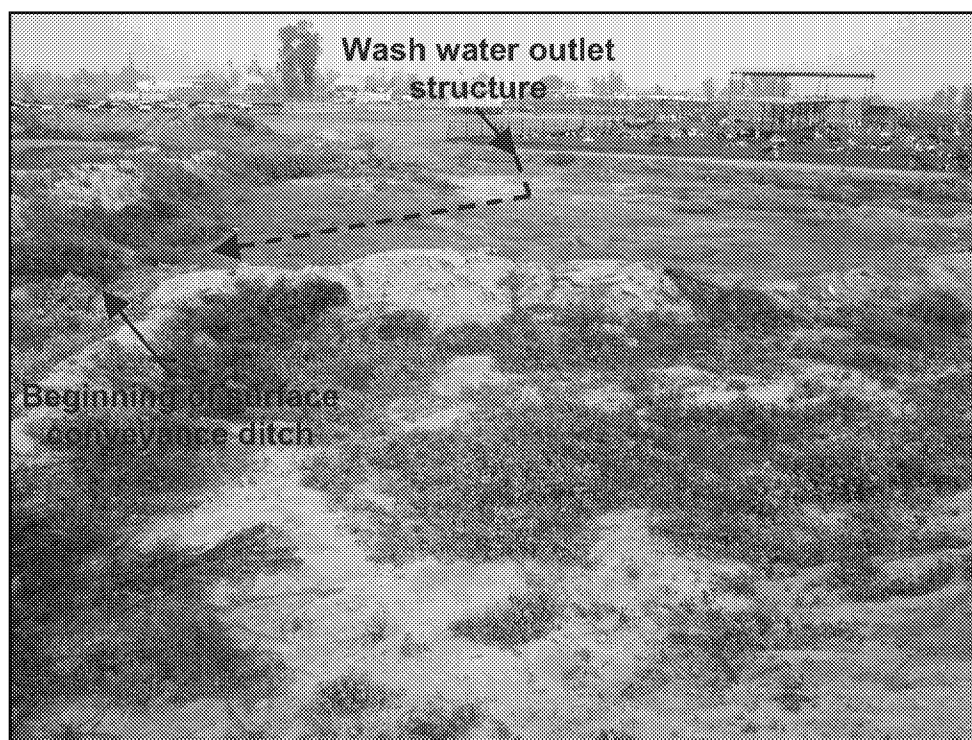
Photograph 9. View facing northwest of the wash water outlet structure shown in Photographs 7 and 8, and the flow pathway into the north/south running surface conveyance ditch.

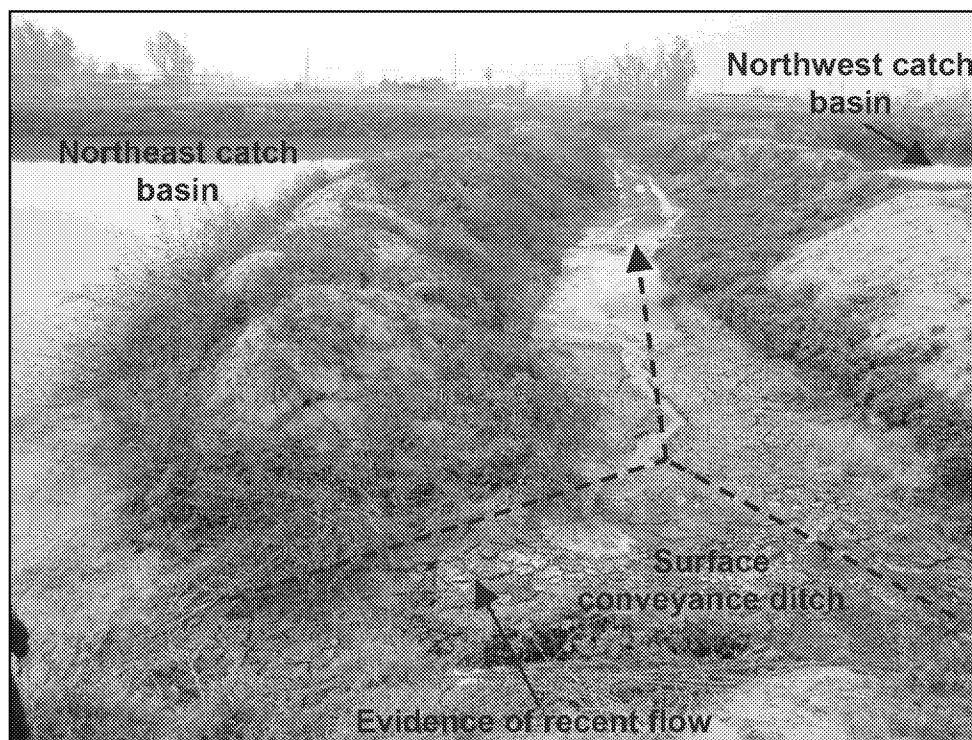
Photograph 10. View facing south of the surface ditch conveying wash water south between the catch basins. Note evidence of recent flow from the northeast catch basin into the surface conveyance ditch was observed.

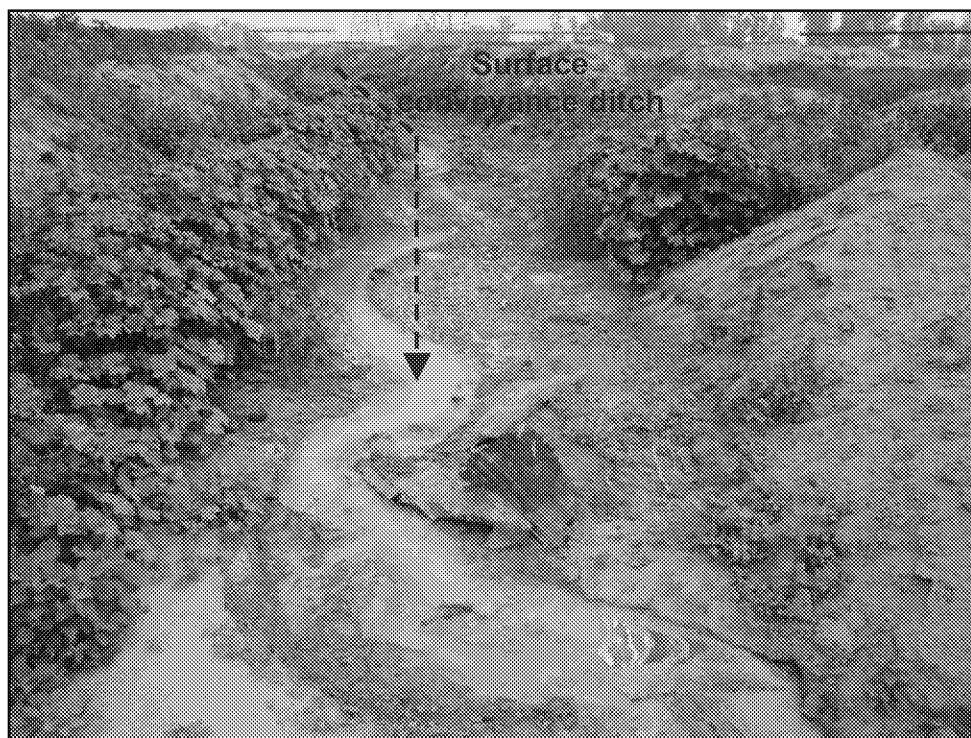
Photograph 11. View facing north of the surface ditch conveying wash water south between the catch basins. Note this process wastewater was observed entering the existing east process wastewater pond in the southeast corner of the Facility, shown in Photograph 12.

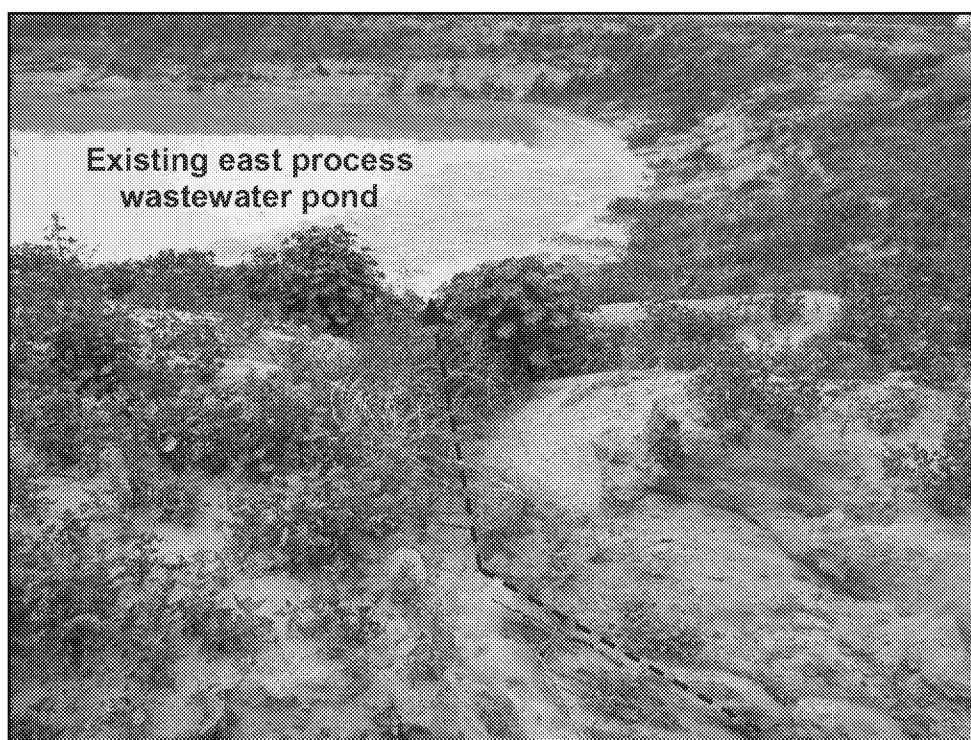
Photograph 12. View facing south of wash water actively flowing into the northwest corner of the existing east process wastewater pond.

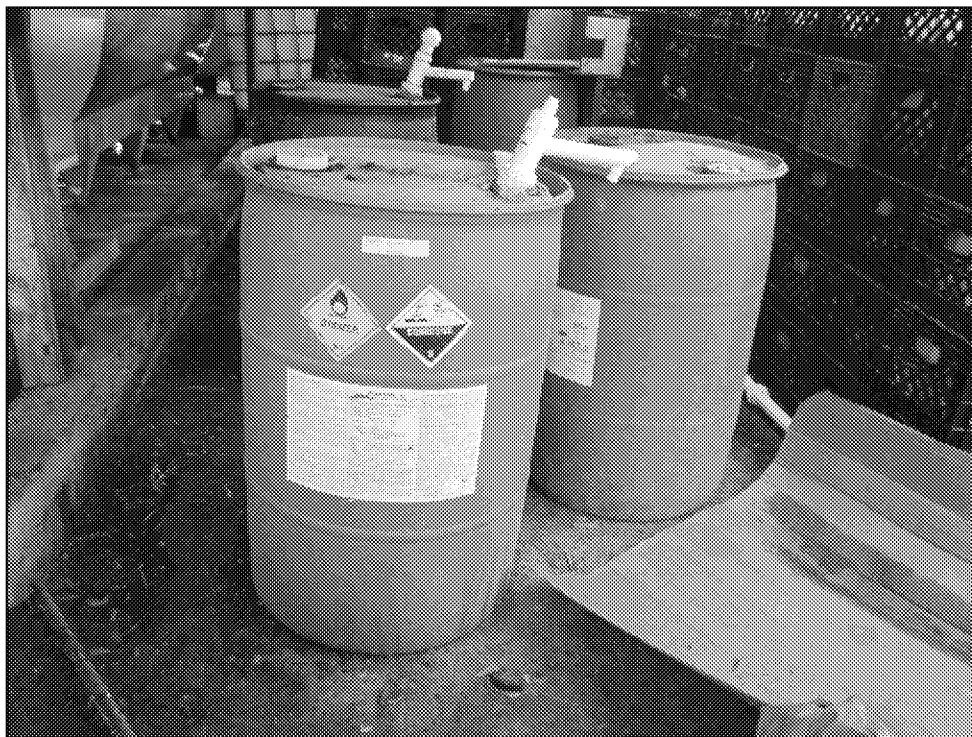
- Secondary containment was not provided for 55-gallons drums of bleach and oxidizer on the west side of the calf milk production area (refer to Photo 13). In addition, a bung cap was missing from a 55-gallon drum of unknown fluid (refer to Photo 13 and 14)

1. The inspectors observed, during the inspection, that secondary containment was not provided for multiple 55-gallons drums of bleach and an unknown oxidizing fluid on the west side of the calf milk production area (refer to Photo 13). In addition, a bung cap was not in place for one (1) of the 55-gallon drums identified above (refer to Photo 14). Provision VII.C.5.h of the Permit states that "chemicals and other contaminants handled on-site shall not be disposed of in any manure, litter, process wastewater, or storm water storage or treatment systems." The inspectors did not observe a disposal of chemical into any of the areas outlined above; however, the lack of secondary containment creates a potential for chemicals to be spilled and/or released into adjacent corrals or the catch basins.

Photograph 13. Close-up view of 55-gallon drums of an unknown oxidizing fluid without secondary containment located on the west side of the calf milk production area shown in Photographs 5, 6, and 7.

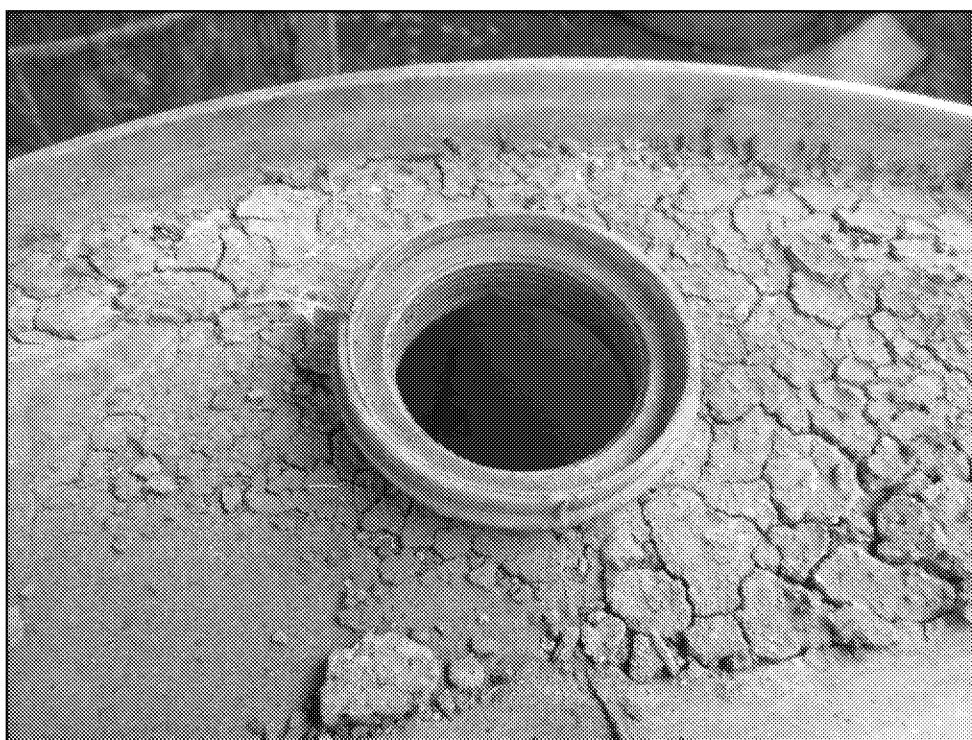
Photograph 14. Close-up view of a missing bung cap on one of the 55-gallon drums of an unknown oxidizing fluid shown in Photograph 13.

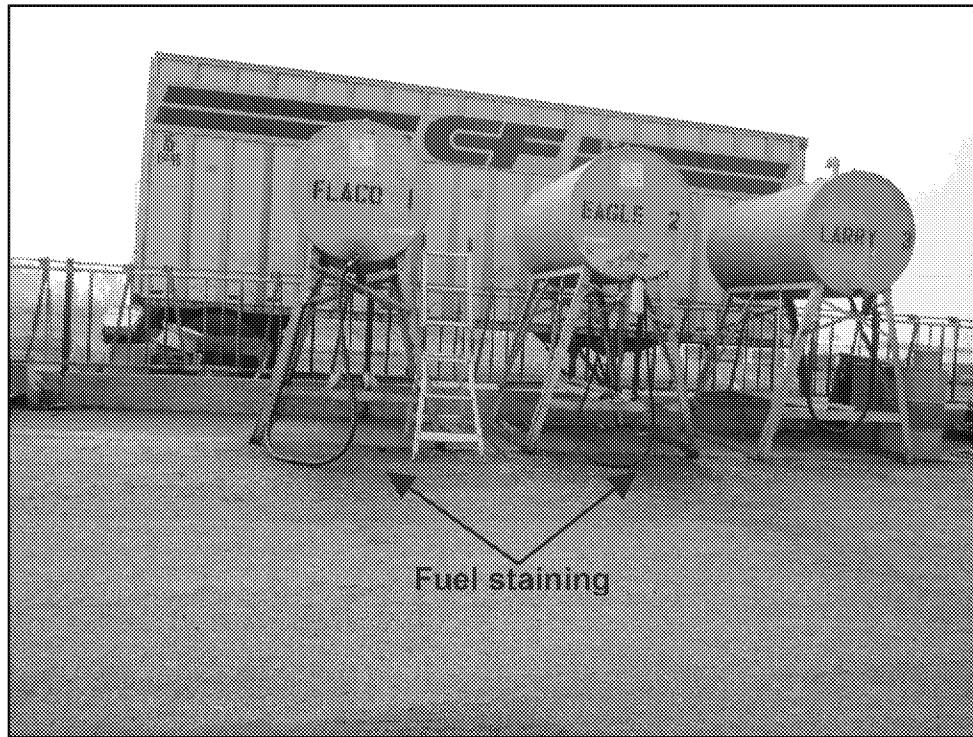
- Fuel staining on the impervious surface from the Facility fueling area was observed in the central portion of the Facility (refer to Photo 15)
- Vegetation growth was observed in the existing west process wastewater pond at the Facility (refer to Photos 16 and 17)

2. The inspectors observed, during the inspection, fuel staining from the Facility fueling area on the impervious surface underneath the fuel tanks in the central portion of the Facility (refer to Photo 15). Provision VII.C.5.h of the Permit states that "chemicals and other contaminants handled on-site shall not be disposed of in any manure, litter, process wastewater, or storm water storage or treatment systems." The inspectors did not observe a disposal of fuel into any of the areas outlined above; however, the fuel staining on the ground surface creates a potential for fuel to contribute pollutants to storm water runoff, which is collected by the Facility containment structures in the southern portion of the Facility.

Photograph 15. View facing south of fuel staining on the impervious surface underneath the fuel storage tanks located in the central portion of the Facility.

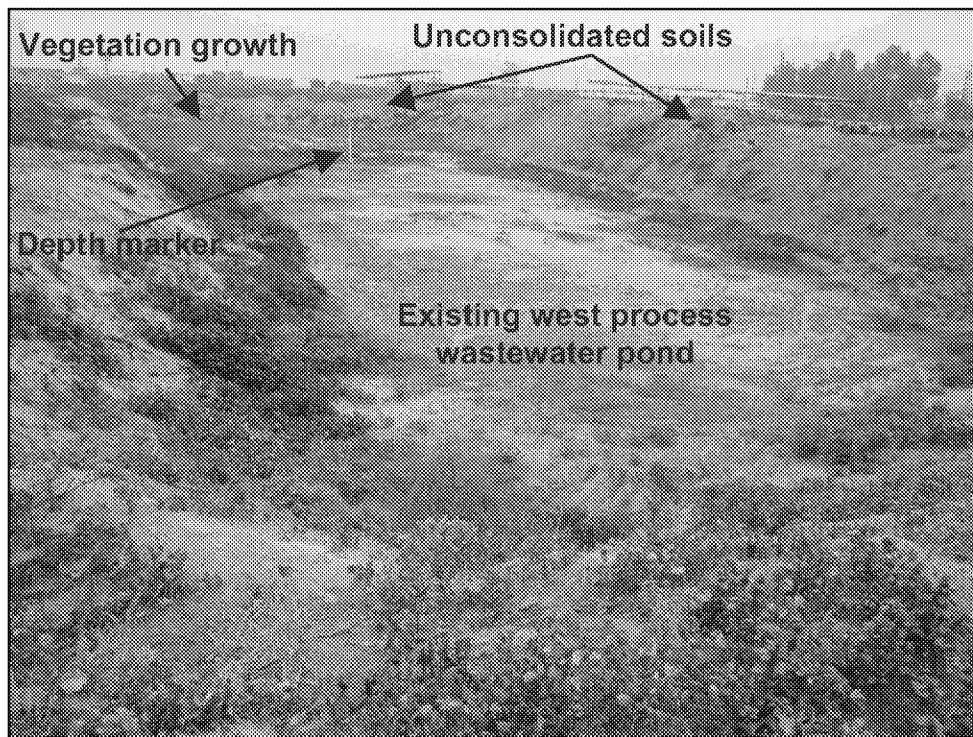
3. The inspectors observed, during the inspection, vegetation growth potentially affecting the containment structure capacity in the existing west process wastewater pond (refer to Photos 16 and 17). The 'Operation and Maintenance' section of the EWMP states that "excessive vegetation growth around containment structures will be controlled with mowing." Weed abatement is performed by Mr. Fulmer periodically; however, vegetation growth was observed inside the pond at the time of the inspection. As a result, the overall capacity of the existing west process wastewater pond at the Facility may be diminished. Provision VII.C.3.a of the Permit states that "the discharger shall design, construct, and maintain containment structures to retain all wastewater within the facility, including all process wastewater and all precipitation on, and drainage through, manured areas resulting

5. The inspectors observed, during the inspection, unconsolidated soil stockpiles along the southern and eastern embankment slopes of the existing west process wastewater pond (refer to Photos 16 and 18). The overflow spillway on the south central side of the existing west process wastewater pond was observed obstructed by multiple unconsolidated soil stockpiles (refer to Photo 18). The 'Proposed Waste Management Plan' section of the EWMP states that "an emergency spillway has been added along the west berm to allow a 100-year, 24-hour storm (52.2 CFS) to flow through at a velocity less than 5.0 feet per second. At this velocity, erosion will not be a concern." As a result of the unconsolidated soil stockpiles location, flow discharging out of the existing west process wastewater pond emergency spillway would be obstructed. In addition, the EWMP states that the emergency spillway is present on the west berm; however, the inspectors observed the spillway had been constructed on the south berm (refer to Photo 18). Provision VII.C.3.a of the Permit states that "the discharger shall design, construct, and maintain containment structures to retain all wastewater within the facility, including all process wastewater and all precipitation on, and drainage through, manured areas resulting from rainfall up to and including a 25-year, 24-hour rainfall event." The Discharger must design and maintain all containment structures per the EWMP as required by Provision VII.C.3.a of the Permit.

Photograph 16. View facing southeast of the existing west process wastewater pond located in the southern portion of the Facility. Note vegetation growth was observed inside the pond and unconsolidated soils were observed on the embankment slopes of the pond. This pond did contain a depth marker.

from rainfall up to and including a 25-year, 24-hour rainfall event." The Discharger must design and maintain all containment structures per the EWMP as required by Provisions VII.C.3.a-b of the Permit.

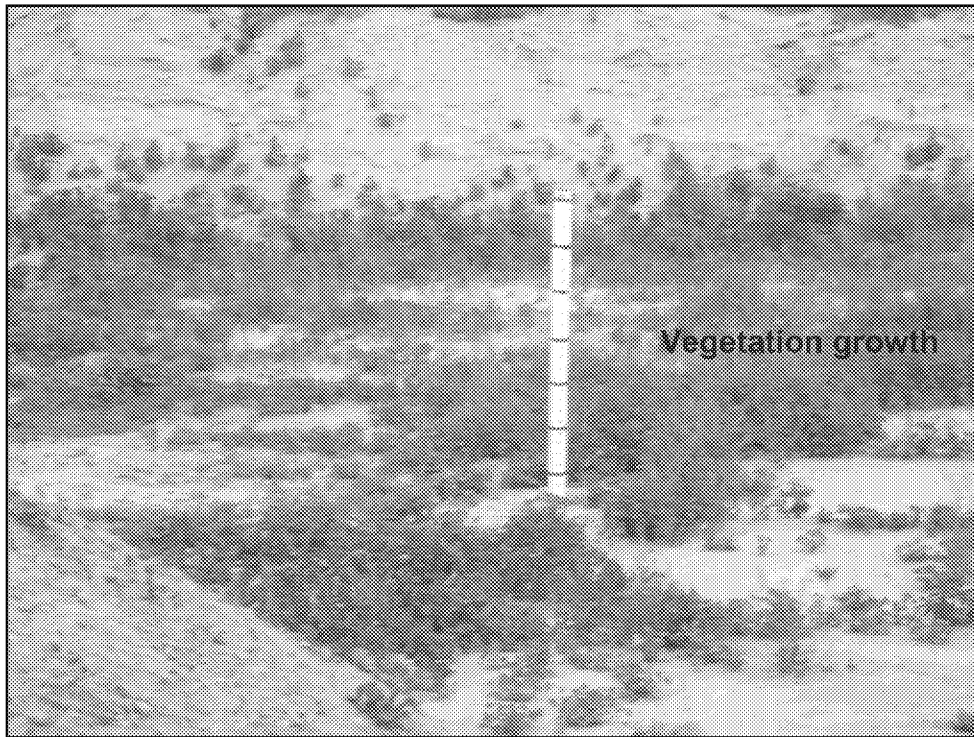
Photograph 17. Close-up view of the depth marker and vegetation growth in the existing west process wastewater pond, shown in Photograph 16.

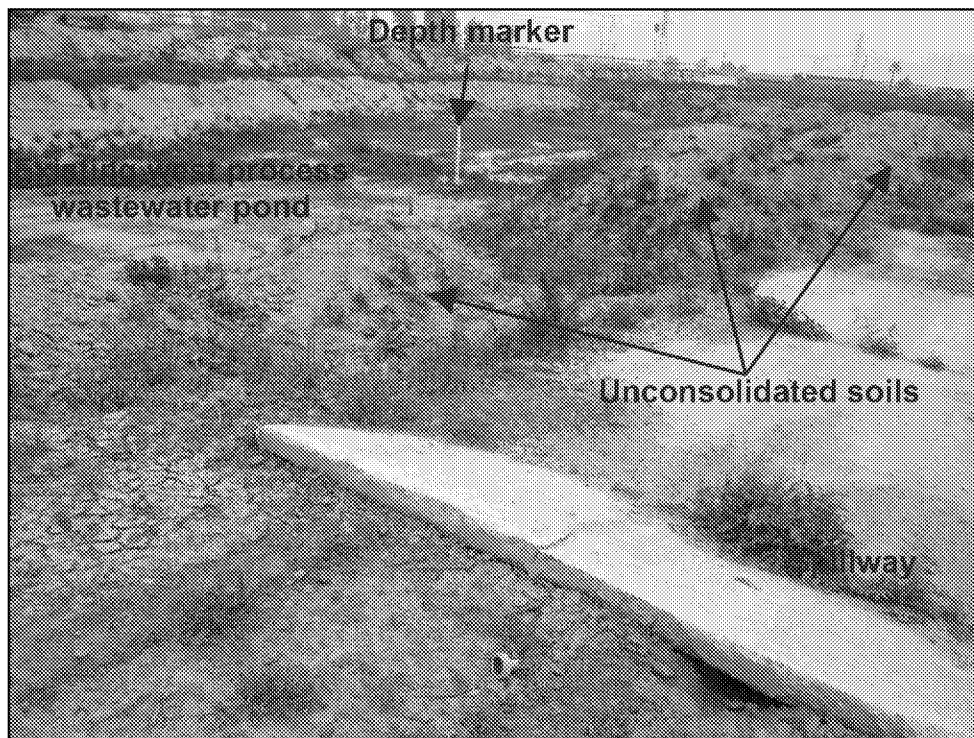
Photograph 18. View facing northeast of unconsolidated soil stockpiles located on the southern and eastern embankment slopes of the existing west process wastewater pond. Note a soil stockpile was obstructing the emergency spillway located on the south side of the pond.

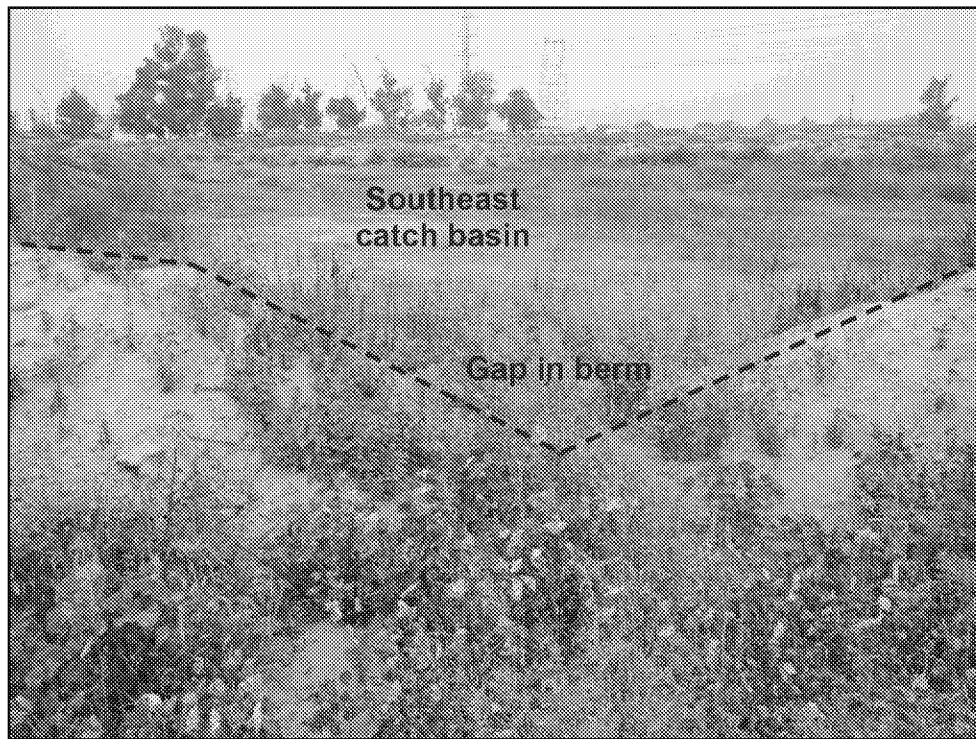
- A gap was observed in the eastern embankment slope of the southeastern catch basin (refer to Photo 19)

6. The inspectors observed, during the inspection, a gap in the containment berm on the east side of the southeastern catch basin (refer to Photo 19). An overflow out of the basin through the gap has the potential to discharge offsite and onto the adjacent dairy, Basque-American No. 1. It should be noted that this catch basin is not identified in the Facility's approved EWMP. Effluent Limitations and Discharge Specifications V.A.1.a specifies that production areas (e.g., waste confinement areas) must be designed to maintain all process water including the runoff and the direct precipitation from a 25-year, 24-hour rainfall event. It should be noted that an issue with Facility containment structure berm maintenance was noted during a previous inspection conducted on December 22, 2012. Provision VII.C.3.a of the Permit states that "the discharger shall design, construct, and maintain containment structures to retain all wastewater within the facility, including all process wastewater and all precipitation on, and drainage through, manured areas resulting from rainfall up to and including a 25-year, 24-hour rainfall event." The Discharger must design and maintain all containment structures per the EWMP as required by Provision VII.C.3.a of the Permit.

Photograph 19. View facing west of a gap in the eastern containment berm of the southeast catch basin, shown in Photograph 3.
